Investigation of the A-7 hook point attachment bolt loosening problem.

INVESTIGATION OF THE A-7 HOOK POINT
ATTACHMENT BOLT LOOSENING PROBLEM

Investigation of the A-7 Hook Point
Attachment Bolt Loosening Problem

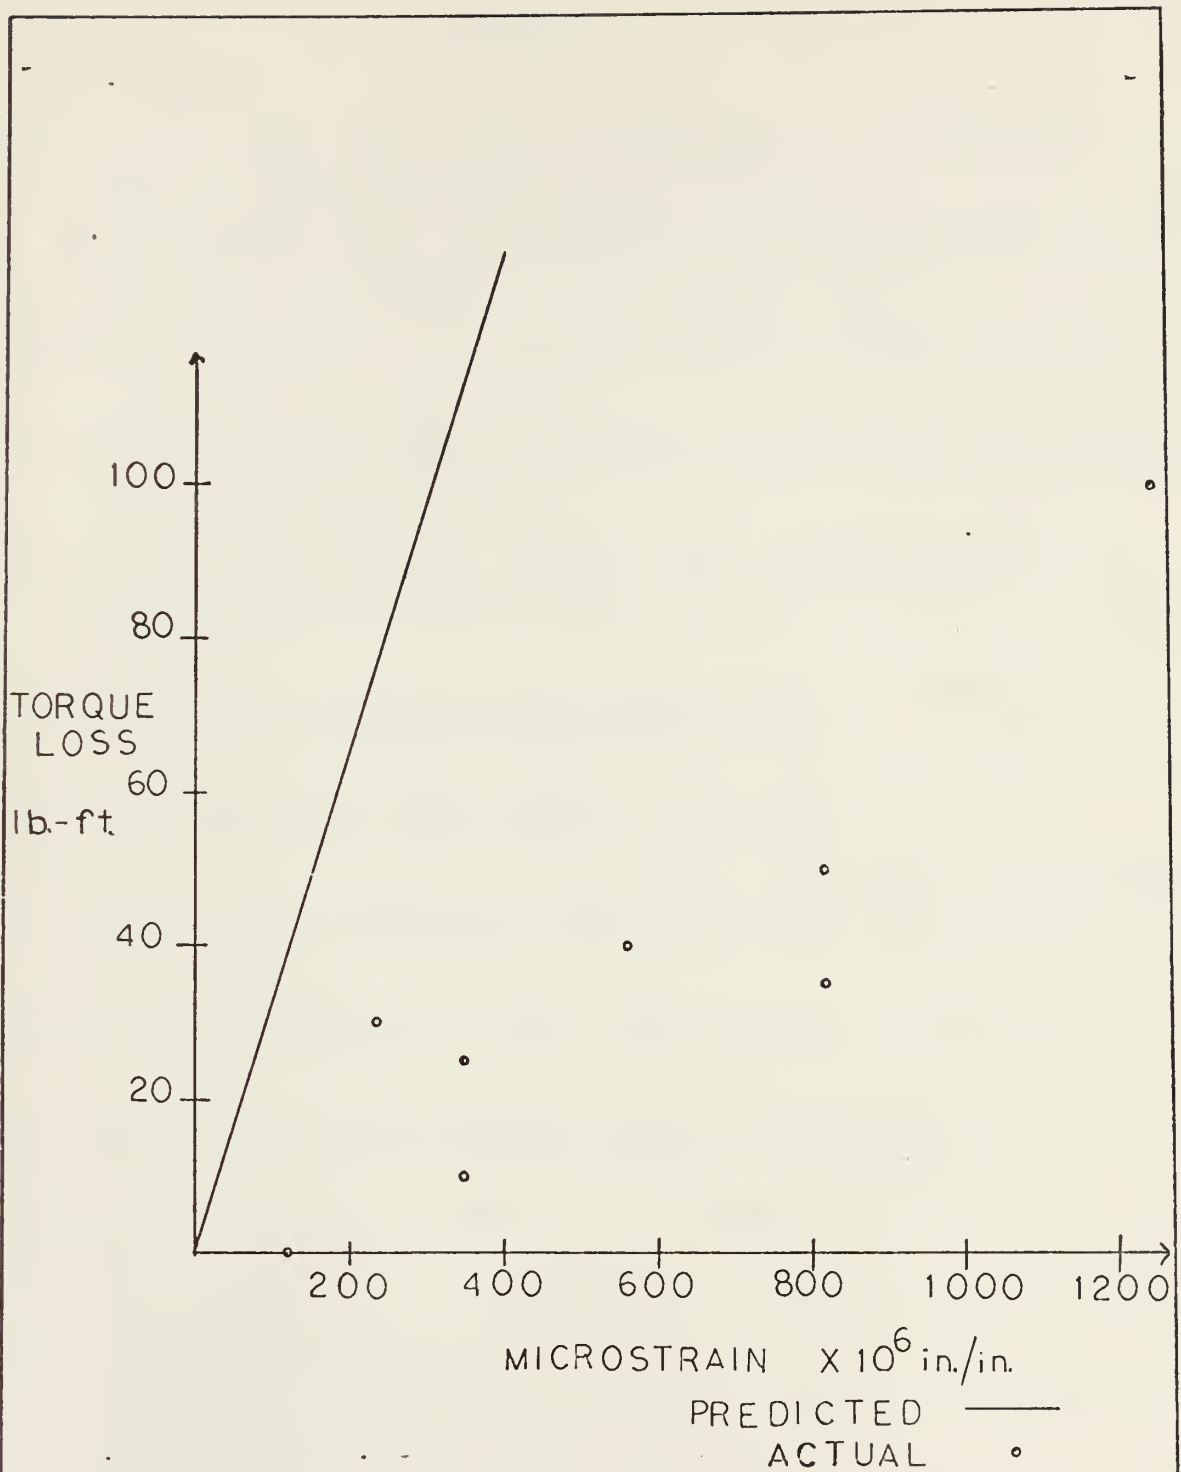
It may be noted that the torque losses actually measured were not in exact agreement with those predicted using the method described in Section III - B. Figure 26 shows a comparison of the actual and predicted data. The reason for this discrepancy seems to be that in the development of the predicting equations it was assumed that the parts being clamped were rigid. This assumption ignores the actual elasticity of the fixtures, which would supply an additional spring constant and reduce the torque loss.

Figure 26. Comparison of predicted torques losses and actual torque losses versus microstrain.
